Mechanisms of micro-groove formation on single-crystal diamond by a nanosecond pulsed laser

Nozomi Takayama, Jiwang Yan*

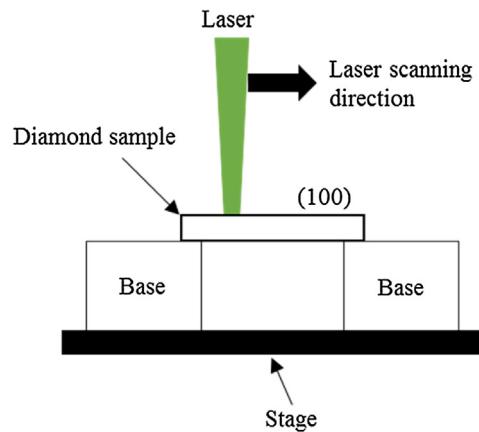
Fig. 1. Laser irradiation schematic for micro-grooving on diamond.

The diamond sample was placed on a base with an opening so that the lower surface was not in contact with the stage surface, as indicated in Fig. 1. As diamond is a transparent material at the laser wavelength used, when the diamond was placed directly onto the stage, the laser energy was absorbed by the stage surface, leaving an irradiation mark on the stage. The heat accumulated by the stage then affected and machined the diamond, also leaving an irradiation mark on the lower surface of diamond. In this case, the laser cannot directly machine the diamond and no meaningful results would be obtained. By using the base, no irradiation marks was

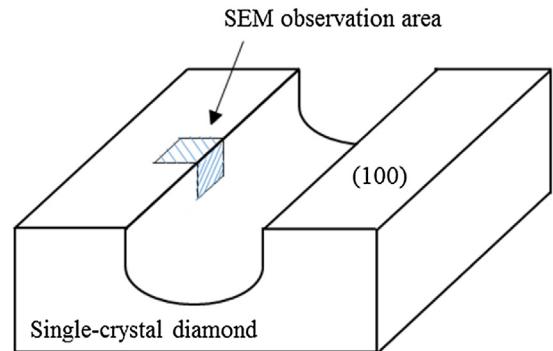
Fig. 2. Schematic of SEM observation area on the groove formed by laser irradiation.

Many cracks were observed on the irradiated surfaces. The schematic for SEM observation is illustrated in Fig. 2. Different sized cracks were formed depending on the laser fluence. As shown in Fig. 3a-d, the cracking region size increased with increasing laser fluence. Upon closer examination, 2 different types of cracks were visible. First, as presented in Fig. 4a, there was a region of wide, open cracks near the groove edge. Second, as shown in Fig. 4b, there were thin straight cracks closer to the center. At the lowest fluence of 5.0 J/cm^2 , no open cracks were visible; instead, there were thin, bent cracks near the groove edge. It appeared that these cracks were similar in structure to the wide, open cracks due to their position and their lack of straightness. Furthermore, as presented

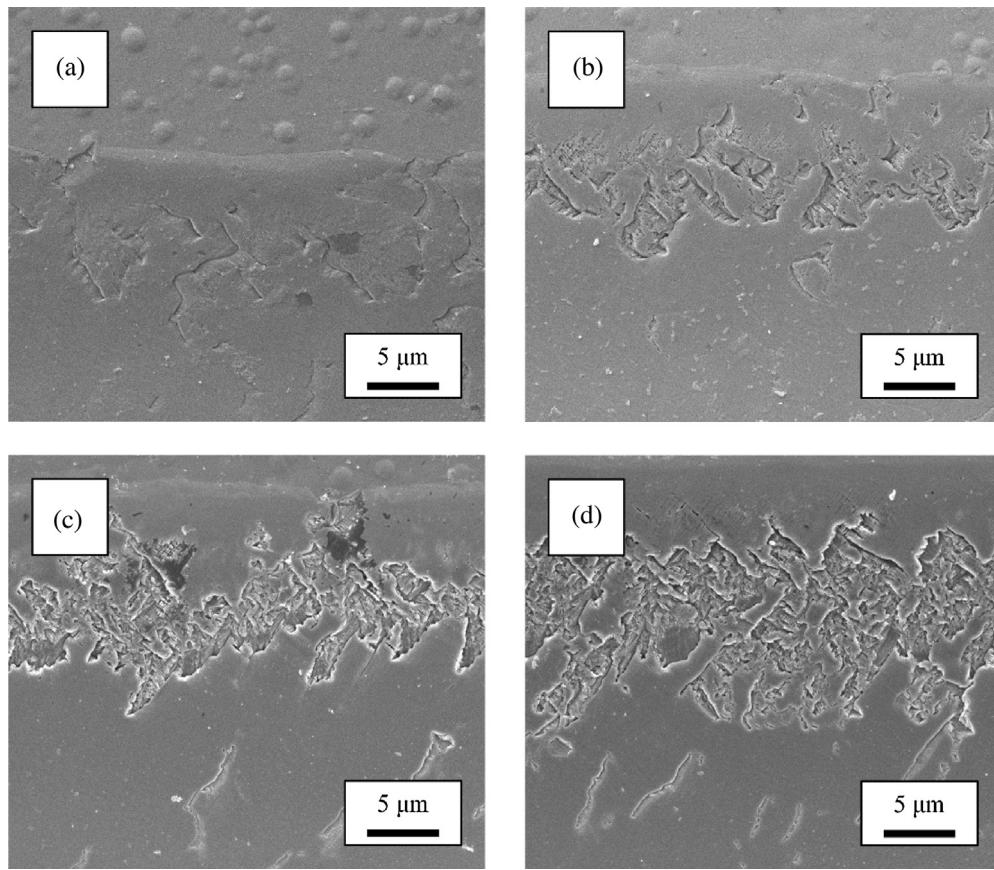
Fig. 3. SEM images of cracks formed near the edge of the groove when using a laser fluence of: (a) 5.0, (b) 6.0, (c) 7.2, (d) 8.4 J/cm².

Beyond this minimum value, the crack length is shown to increase with ΔT . A greater laser fluence leads to greater absorbed energy and a greater temperature change. Therefore, longer cracks are produced when using a greater laser fluence. The SEM images of Fig. 3 agrees with this, where larger cracks were found at higher fluences.

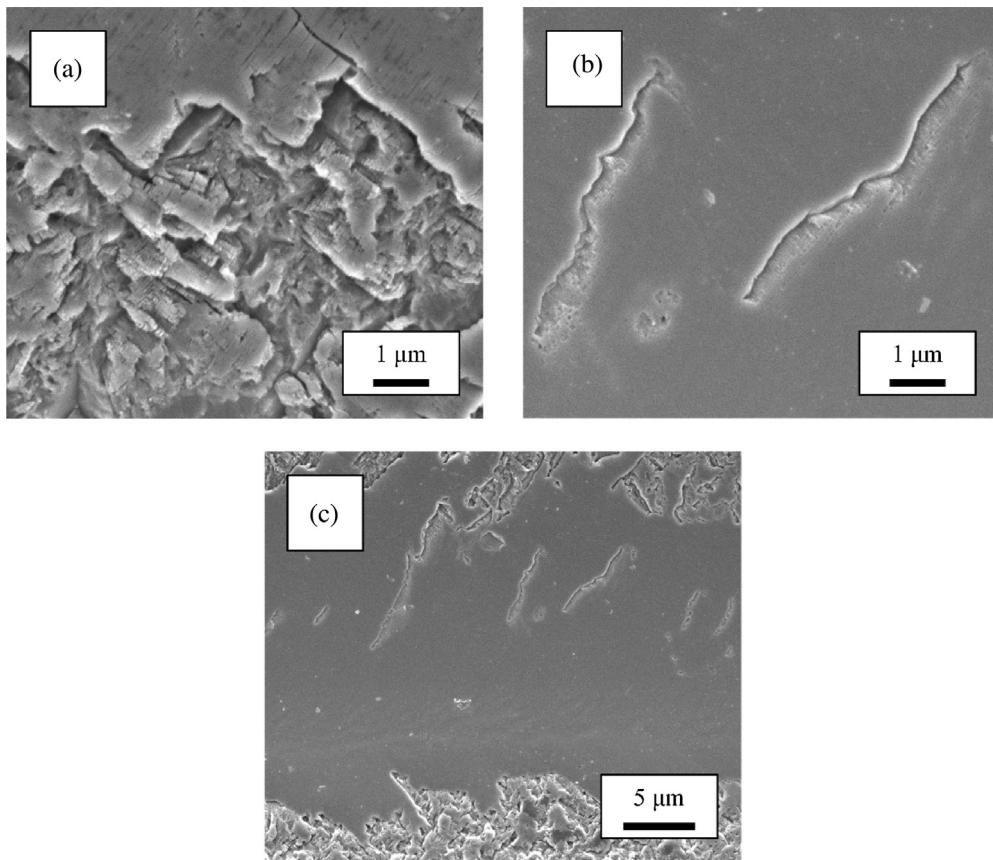
Fig. 4. Closer examination by SEM of cracks formed near the edge of the groove using a laser fluence of 8.4 J/cm^2 showed: (a) large area cracks, (b) thin cracks, (c) a smooth region in the center of the groove.

in Fig. 4c, there was a smoothed, crack-free region in the center of each groove. The difference between the 2 different crack types can be explained by looking at the depth that they exist. The wider open cracks occur at a shallower depth of $\sim 1 \mu\text{m}$. These open cracks are easily propagated over a large area even with a low laser fluence. Crack propagation is facilitated by the existence of a near-surface defect layer that is formed during polishing. Therefore, despite the surface appearing to be damage-free, it is likely that a $\sim 1 \mu\text{m}$ layer of pits, scratches and potential micro-cracks exists under the polished surface as shown by Lee (2011). The thinner cracks seen in the groove produced by irradiation using 8.4 J/cm^2 laser fluence, most likely originated from deeper, smaller defects, and thus require a greater laser fluence to be propagated.

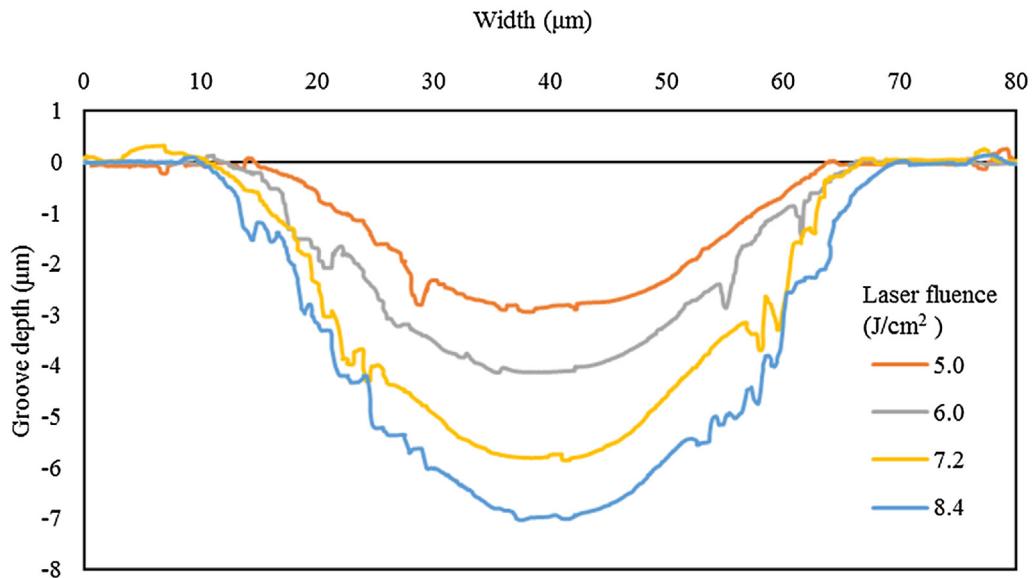
Fig. 5. Cross-sectional profile of grooves produced by varying laser fluences.

The cracks and smooth region were further considered by measuring the cross-section profiles of the grooves and the results are shown in Fig. 5. The intensity at the edge of the groove is the ablation threshold. This is followed by a region of cracking and then a smooth region exists in the center. Therefore, smoothing effects occur at a higher fluence than cracking. Within the cracking region, the crack propagation depth is greater than the ablation depth. Therefore cracks remain in the substrate even after irradiation. However, in the smooth region, as a greater amount of energy is irradiated, the ablation depth becomes greater and complete removal of the cracking layer becomes possible. Additionally, the thermal diffusion depth L , or the distance a temperature change propagates within a single pulse due to thermal conduction, is estimated to be roughly $2 \mu\text{m}$ from the relation $L = (\alpha t_0)^{1/2}$ where α is thermal diffusivity and t_0 is the pulse width (Zahedi et al., 2015). As we have observed crack propagation and therefore evidence of temperature change at a greater depth, we can assume that the cumulative heating effect of multiple pulses led to an increasing ΔT .

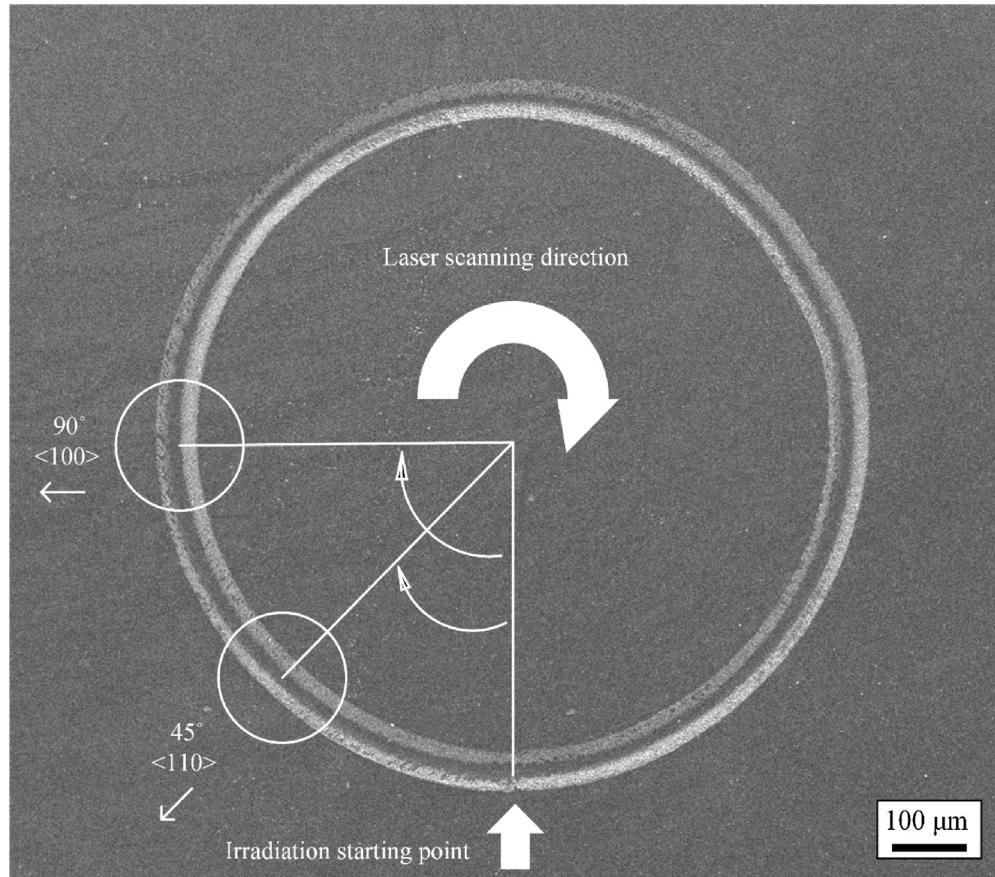
Fig. 6. SEM image of the 1 mm diameter circular groove, irradiated by a laser fluence of 8.4 J/cm². The angle, crystal orientation and observation regions are indicated.

plane, a circular groove was irradiated using the same parameters as the other experiments and a laser fluence of 8.4 J/cm^2 , resulting in a groove as shown in Fig. 6. Upon close examination of the cracks, it was observed that the cracking direction, taken relative to the laser scanning direction, changed every 45° of the groove. As shown in Fig. 7a–c, at the point 90° from the irradiation starting point, where the laser scanning direction is perpendicular to the <100> direction, the cracks are generated at an angle to the laser scanning direction. On the other hand, as shown in Fig. 7d–f, at the point 45° from the irradiation starting point, where the laser scanning direction is perpendicular to the <110> direction, the cracks are generated perpendicular to the laser scanning direction. The cracking direction was shown to change every 45° following the same pattern. This resulted in the cracking direction being constant, regardless of laser scanning direction, thus appearing to be dependent on some inherent material property. This property could be crystal orientation and the prominent cracking direction could be along the plane (111).

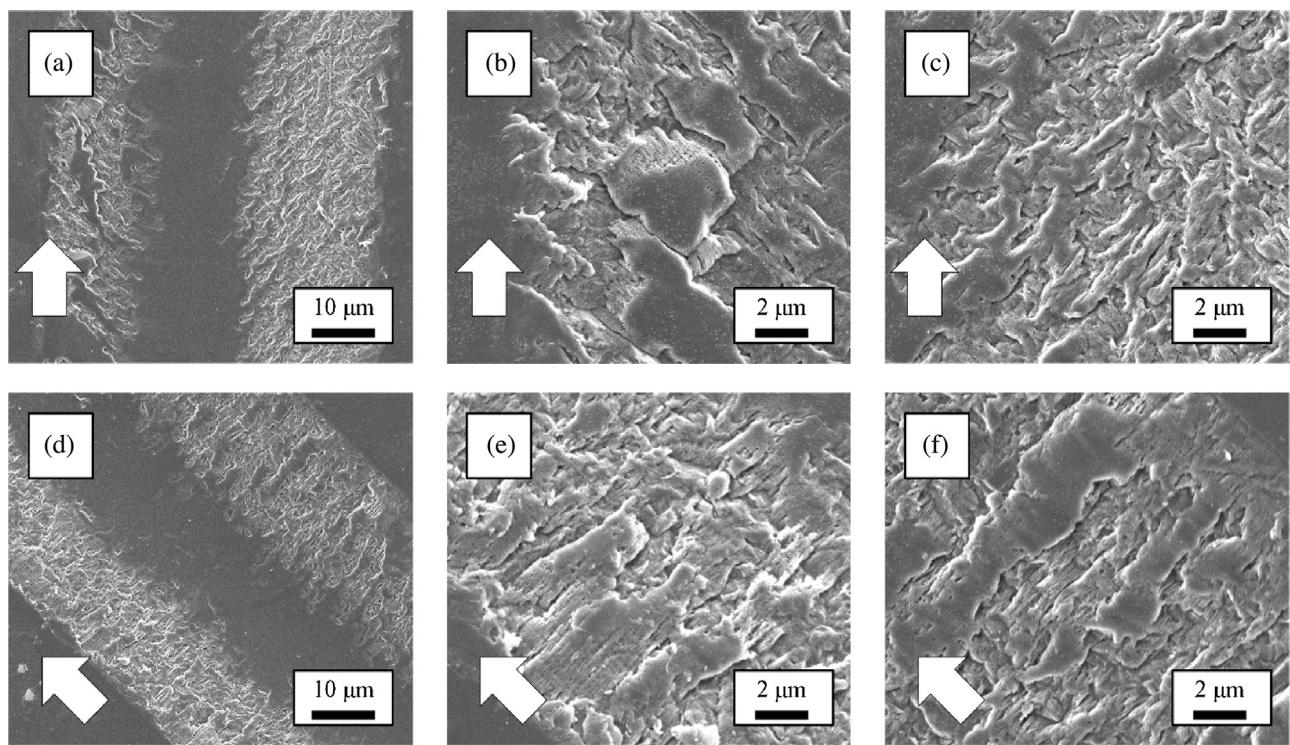
Fig. 7. SEM images of cracks formed near the edge of the circular groove at an angle of 90° or the <100> direction: (a) the entire groove, (b) the outer edge, (c) the inner edge, and of 45° or the <110> direction: (d) the entire groove, (e) the outer edge, (f) the inner edge. The laser scanning direction is shown by a white arrow.

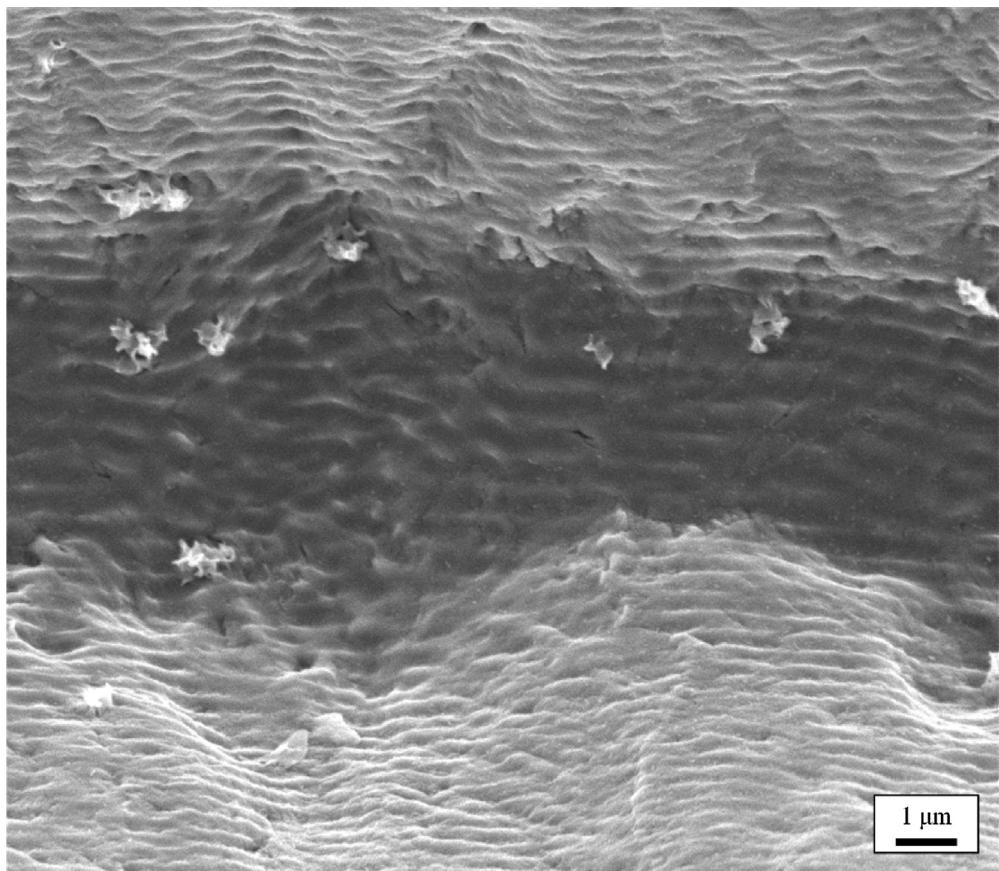
Fig. 8. Ripples observed on the groove walls and bottom produced by irradiation with 20 passes and a laser fluence of 5.0 J/cm².

the groove for irradiation with 5 passes and above, as indicated in Fig. 8. It is important to note here that they were only observed inside the groove; although the area outside the groove had also been irradiated, there were no ripples detected. The ripples formed were parallel to the laser scanning direction and were observed on both the groove walls and the groove bottom. The distance between

the ripples was 0.4–0.5 μm, which is close to the laser wavelength of 532 nm.

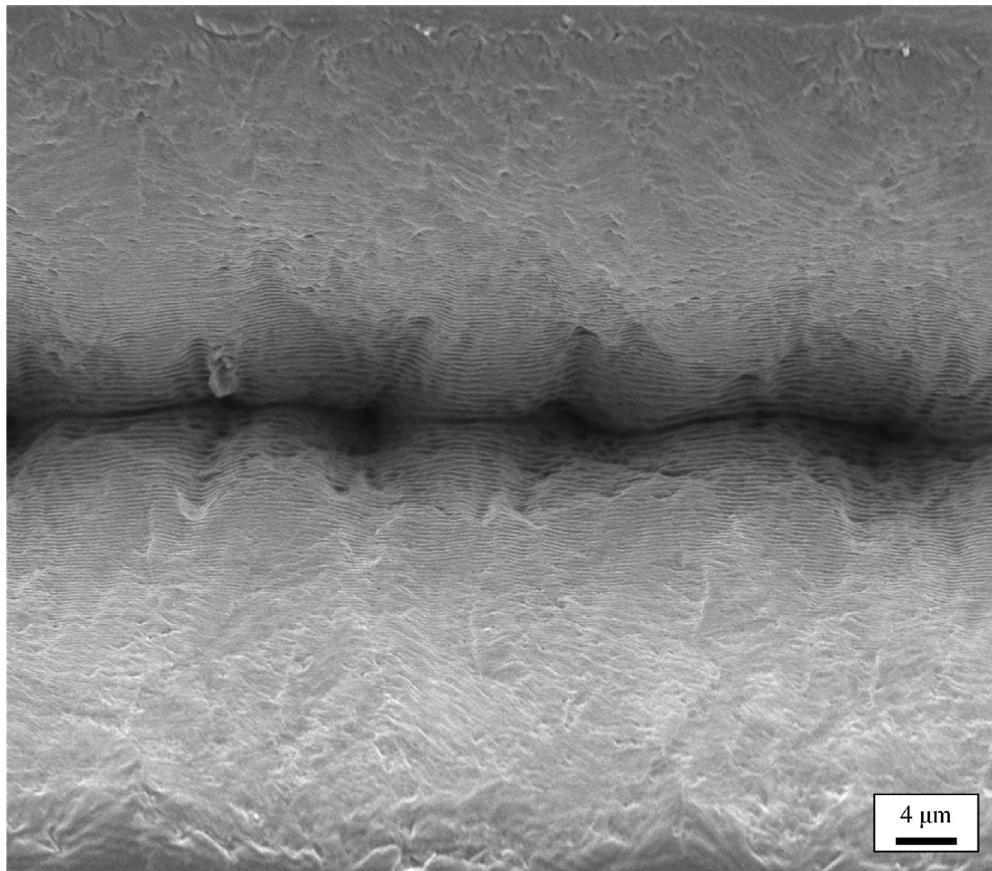
Fig. 9. SEM images of the ripples formed when diamond was irradiated using an argon stream.

experiment was conducted. The experiment for 50 passes was repeated using a 0.3 MPa argon gas stream in order to remove the plasma formed during irradiation. Despite the use of the gas stream, the ripples remained as shown in Fig. 9.

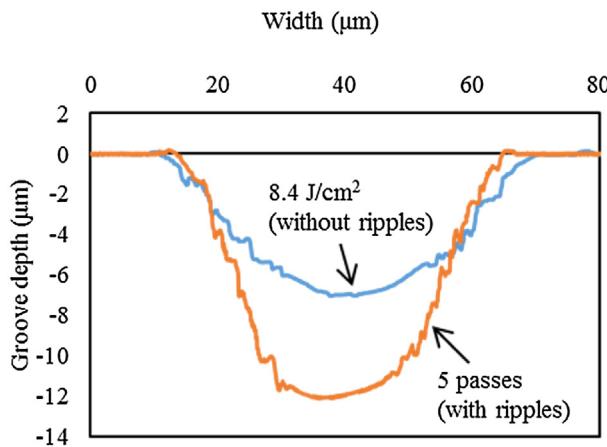
Fig. 10. Cross-sectional profile of grooves produced by 5 passes at $5.0 \text{ J}/\text{cm}^2$ and for 1 pass at $8.4 \text{ J}/\text{cm}^2$.

As the initially considered causes of the ripples were all shown to be irrelevant, ripple formation was considered in relation to groove depth. Fig. 10 presents the cross-sectional profile of the groove formed by 5 passes at $5.0 \text{ J}/\text{cm}^2$ and by 1 pass at $8.3 \text{ J}/\text{cm}^2$.

This shows that the ripples form when the groove depth is above a certain value. With a greater depth, the groove wall is steeper. When the walls are steep, the light is reflected from the groove walls and these reflected light rays interfere with each other within the groove. Mildren (2013) showed that diamond has a reflectivity of $\sim 17\%$. This interference creates an intensity distribution with a period equal to the wavelength.

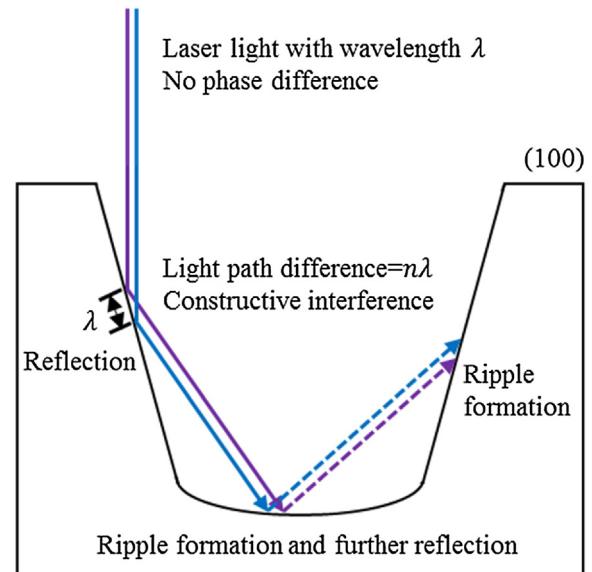
Fig. 11. Schematic for constructive interference and ripple formation.

To describe this process in detail, initially the groove wall is rough and can be seen to contain ripples of many different periods. However, when light is incident on and reflected from ripples with a period equal to the wavelength λ , the light path difference is equal to roughly $n\lambda$, where n is an integer. The light interferes constructively via the mechanism illustrated by Fig. 11 and the intensity reaches a maximum. The ripples with a period of λ gradually

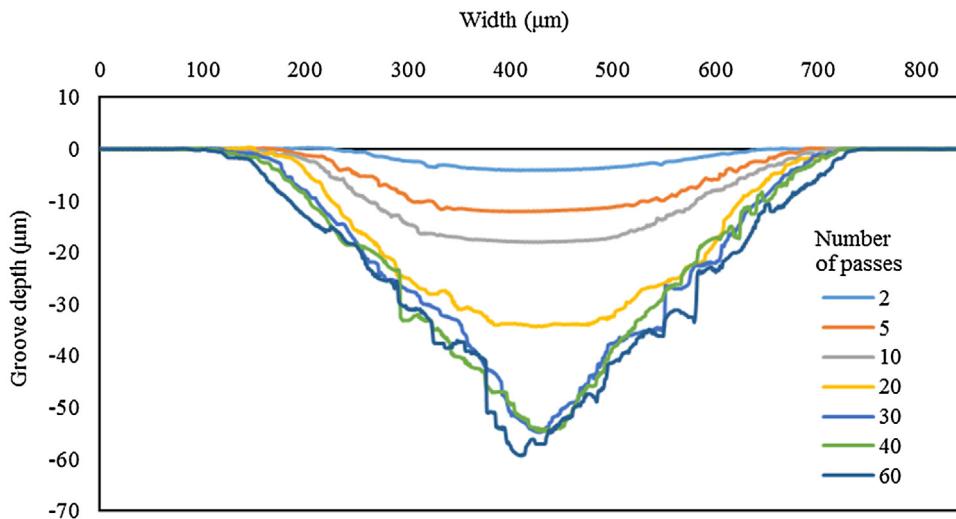
Fig. 12. Cross-sectional profile of grooves produced by a varying number of passes at $5.0\text{J}/\text{cm}^2$.

Fig. 12 shows the results of measuring the cross-sectional profile of the groove for irradiations with varying pass numbers. As the number of passes was increased, the groove no longer had a near-Gaussian profile. This deviation has several characteristics. Up to 10 passes, the groove was a comparatively smooth curve. At 20 passes, the groove walls became steeper but the center is still smooth. This may be because less laser energy is absorbed on a smooth surface compared to a cracked surface. Above 20 passes, the groove profile became V-shaped. The gradient of the groove walls do not change and ablation is concentrated at the groove bottom.

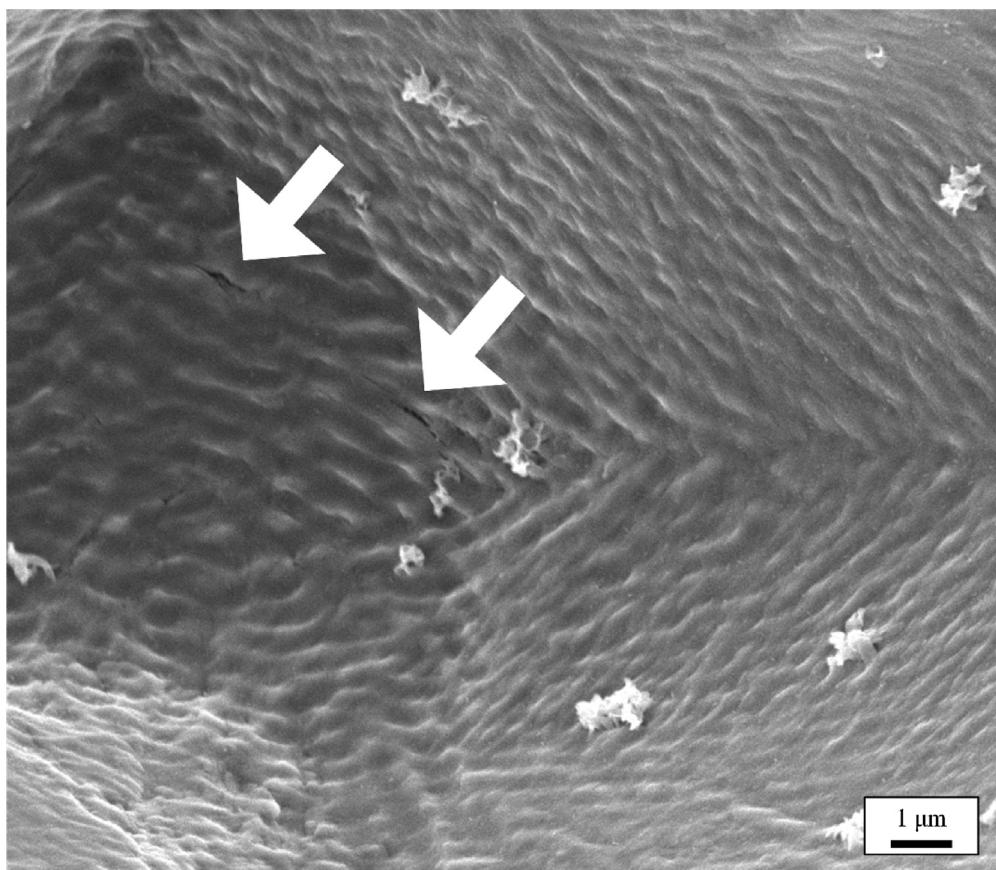
Fig. 13. The bottom of the groove produced by 20 passes at a laser fluence of $5.0\text{J}/\text{cm}^2$, where cracking is visible.

Some cracks are visible as in Fig. 13. Additionally, there seems to be a limit to the groove depth produced as indicated in Fig. 14. This transfer in laser-induced phenomena from material removal by ablation (20 passes and below) to crack propagation (above 20 passes) can be explained using the following mechanism. From the research of Kononenko et al. (1998), it is known that deep structures result in reduced ablation as absorption by the plasma becomes enhanced. In deep grooves, plasma movement becomes restricted and the plasma remains in the groove. It blocks further laser energy from reaching the substrate surface. Therefore, even if the diamond is irradiated with many passes, the plasma prevents further material from being ablated. Moreover, it is possible that, due to enhanced absorption, heat accumulation occurs within the plasma. Laser energy absorbed by the plasma is converted into internal energy of the plasma and radiated onto the substrate surface (Carpene et al., 2010). This heating of the surface appears to have caused increased crack propagation. To reduce shape deformation and plasma induced cracking, a single pass should be used. For a deep groove, a higher fluence may be needed.

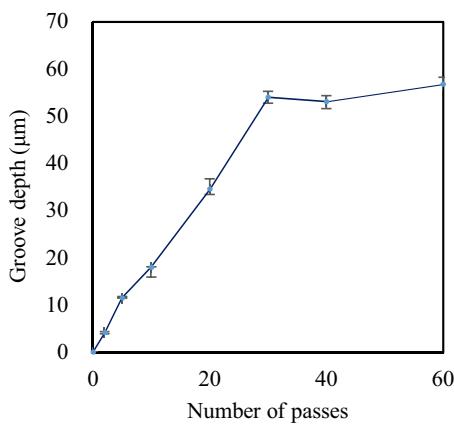
Fig. 14. Groove depth in relation to the number of passes.

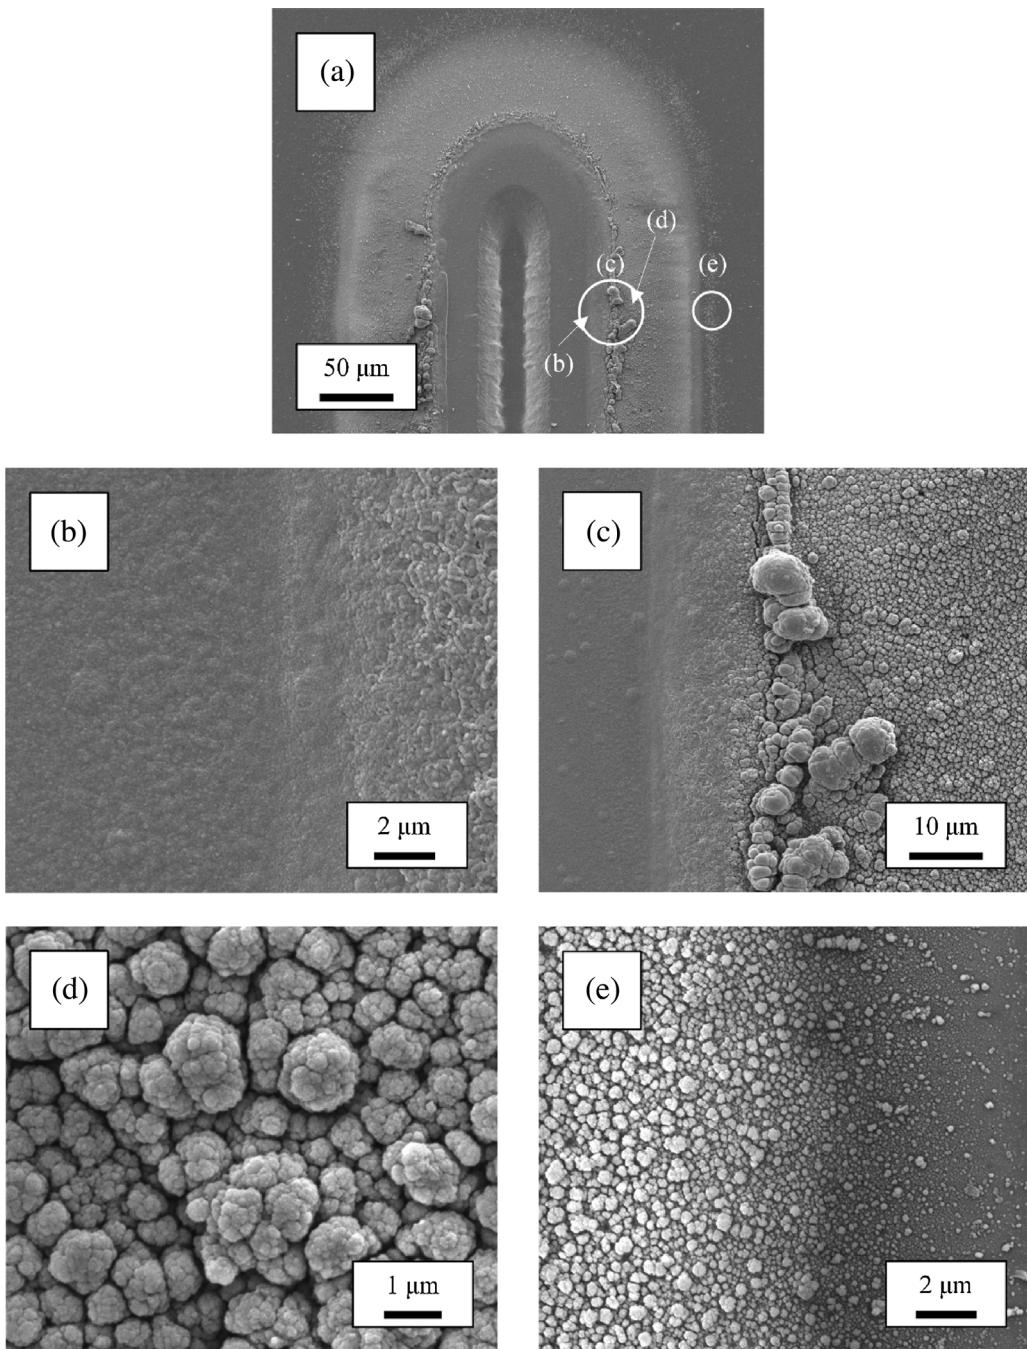
Fig. 15. SEM images of debris produced at 5.0 J/cm^2 with 20 passes: (a) the entire groove, (b) thin layer of debris deposition, (c) large debris particles, (d) small round parricles, (e) decrease in particle size.

To examine debris deposition, we observed the irradiation groove before the cleaning process. Fig. 15a shows the debris deposition around the groove produced by irradiation of 20 passes. The debris formed a cloud around the groove, and from the Raman spectrum shown in Fig. 16a, the debris was identified to be disordered graphitic carbon as it exhibited a D band at 1356 cm^{-1} and a G band at 1589 cm^{-1} (Knight and White, 1989). This is a very interesting

result as, although previous studies have discussed the formation mechanism of graphite (Jeschke et al., 1999), they have not focused on the deposition of the graphitic debris cloud. As shown in Fig. 15a, the cloud contained a variety of particles. In the region closest to the groove, there were few particles. It is likely that the laser-induced plasma shielded this region from the deposition of debris particles. In an ambient gas, high plasma plume pressure drives its initial expansion as if it were occurring in a vacuum (Schou et al., 2007). Therefore this initial high pressure prevented debris deposition. As presented in Fig. 15b, only a very thin layer of extremely small (\sim submicron size) debris particles were deposited in this region. As presented in Fig. 15c, at the edge of this flat region, there were many large ($\sim 10\text{ }\mu\text{m}$) debris particles. As these particles are large, they may have been too heavy to travel any further. Beyond this wall of large particles, many small round particles were observed, shown in Fig. 15d. They appeared to be a coagulation of even smaller circular particles. As the distance from the groove increased, the particle size decreased, as indicated in Fig. 15e. The Raman spectra of these regions of debris were further examined. The shielded inner region, shown in Fig. 15b, exhibited a larger D/G intensity ratio compared to the outer region as shown in Fig. 16, indicating a greater amount of graphitic debris in the outer region. As a side note, Kuznetsov et al. (1999) stated that (100) surface of diamond requires much more atomic rearrangement to form a graphite plane compared to (111) and (110) surfaces. Thus it is possible that the results show the least laser-induced graphite out of irradiation of all other crystal planes.

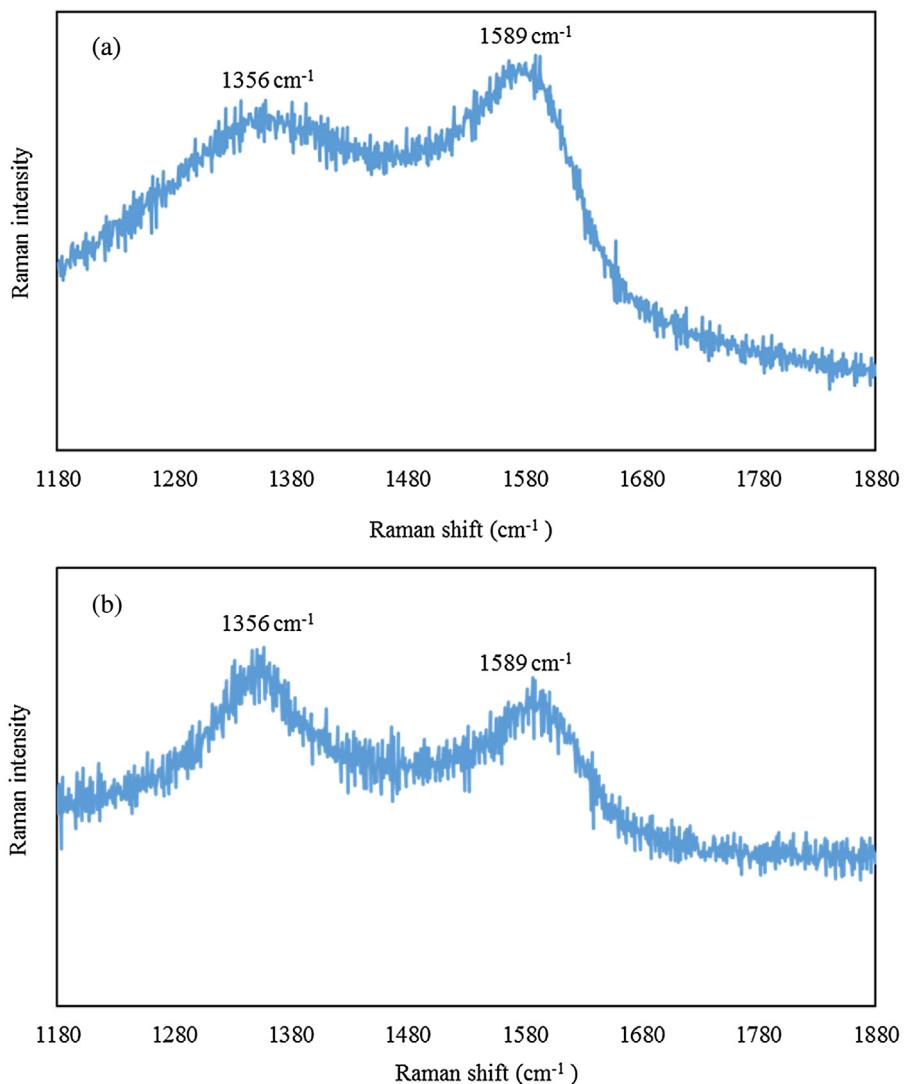
Fig. 16. Raman spectra of: (a) the debris cloud and (b) the shielded inner region, formed around the groove produced with laser irradiation with 5.0 J/cm² and 20 passes. Note that (a) shows a stronger graphite peak compared to (b).

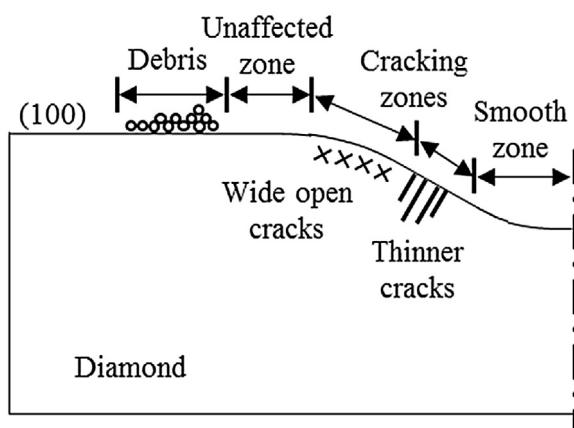
Fig. 17. Model of surface morphologies after irradiation.

Relating these observations to the cracking mechanism, it is possible to create a model representing the surface morphologies after irradiation as illustrated in Fig. 17. It is possible to divide the morphology into the following categories: a debris deposition zone, a laser unaffected zone, a cracking zone, and a smooth zone.

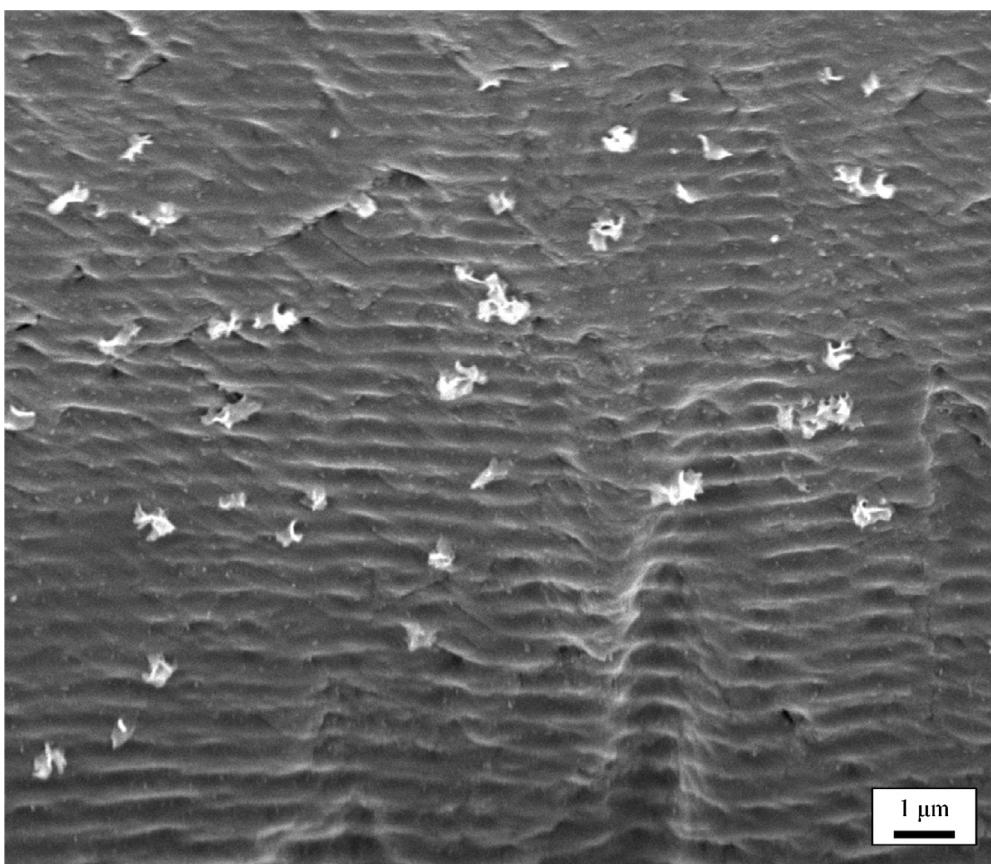
Fig. 18. Debris on the walls of the groove produced by 30 passes at a laser fluence of 5.0 J/cm^2 .

In addition to debris around the groove, some debris was observed inside the groove even after cleaning as presented in Fig. 18. This type of debris was small ($\sim 1\text{ }\mu\text{m}$), irregularly shaped with sharp edges and were observed for a pass number greater than 20. This may be the result of spallation, demonstrated by Körner et al. (1996), where elastically stored energy enables unstable crack growth and pieces of diamond are broken off in a violent and explosive process.
